Inspection Report

Minerals Regulatory Program

Mine Name: Lisbon Valley
Operator Name: Lisbon Valley Copper

Permit number: M0370088
Inspection Date: July 30, 2008
Time: 8:00-9:45 AM

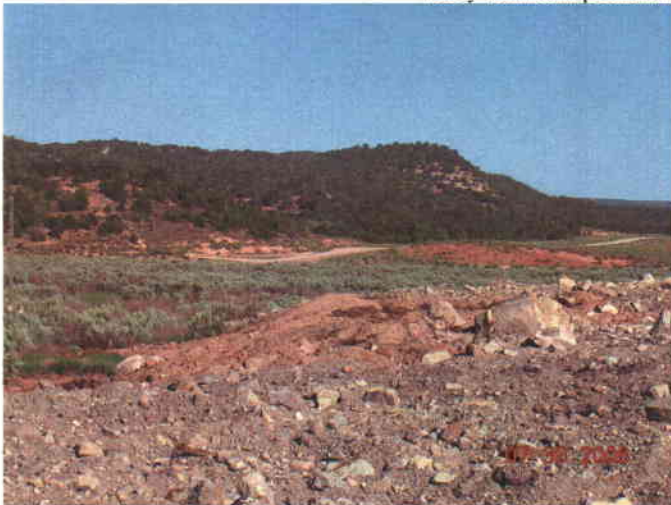
On the haul road near the Sentinel pits, the operator has left an area that could, if necessary, be graded to allow soil to be brought in. There are a few small areas with soil on the surface.

The growth medium on the haul road by the Sentinel pits has a lot of coarse fragments (rocks), but the smaller size fraction has a lot of clay. I have some concern about this, but I believe the degree of roughness and the amount of rock may help compensate for the clay content.

Photo 1. This is one of the haul roads near the Sentinel pits. Note the degree of roughness and the amount of rock on the surface which should be very beneficial for plant growth. The center of the photo shows an area where the operator was able to apply some soil.

As much as possible, the operator should try to seed immediately after surface preparation is complete. Otherwise, the soil tends to form a crust and not allow the seed a good place in which to germinate. The rock should help create microsites in which the seeds can germinate.

I asked Mr. Brown to try to leave as little of the dark clayey material on the surface as possible. I'm sure he will do his best in this regard, but he also pointed out that some of the old waste dumps at the GTO pit are mostly clay and have good vegetation cover. We looked at these areas. Where the slopes were not too steep and where there was not too much compaction, there was a good stand of green rubber rabbitbrush.

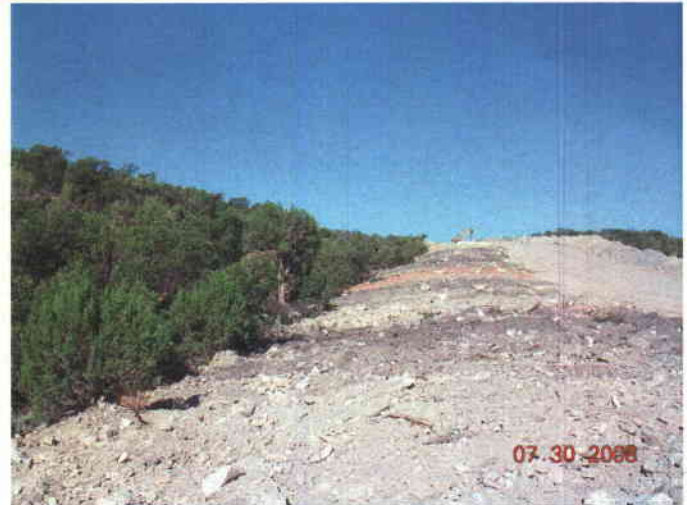
The operator has been reclaiming some of the haul roads using a trackhoe and has done outstanding work. The areas have been nicely roughened, and there is a lot of rock on the surface (see photos). Because the operator is using a trackhoe rather than a dozer, it has been possible to pull the berms in to the disturbed area rather than trying to go outside the disturbed area and push in the berms. Using a dozer on the haul roads would increase the size of the area needing to be reclaimed, and it is nearly impossible to rip the roads correctly (parallel to the contour) because of the linear nature of the roads. In my experience, the roughness created by a trackhoe is superior to ripping or to grouzer marks.

Photo 2. This is a haul road south of the Centennial pit. The operator has been able to use a trackhoe to pull the berm away from the trees and into the road. The operator is also doing a very good job roughening the surface. Because of the short distance across the road, it would be very difficult to use a dozer to rip this type of area parallel to the contour.

The operator should continue reclaiming the haul roads, and I recommend that the operator use a trackhoe for this work for the reasons stated above. There are other areas, such as the waste dumps, where a dozer would be more efficient to push material and to rip long areas.
